CHLORIDE STRESS CORROSION CRACKING: *CAUSES & SOLUTIONS*

By Howard Hilborn

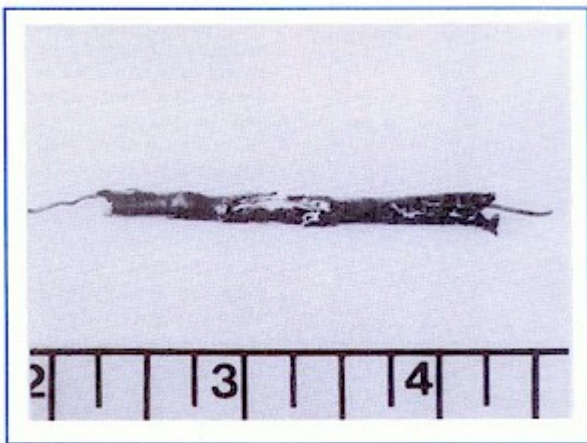
Figure 1

This photo, at 1-1/2 times the actual size, shows the severity of sheath cracking of the affected thermocouple.

Since the thermal gradient zone can't be practically eliminated in most cases, and in fact is not detrimental of itself, the solution is found in eliminating the chloride concentration cell. This can usually be accomplished by installing a secondary seal on the pipewell and keeping the pipewell pressure sealed at all times during operation and turnaround. The additional of a secondary seal has the added benefit of preventing the process from escaping to atmosphere in the event of thermowell failure.

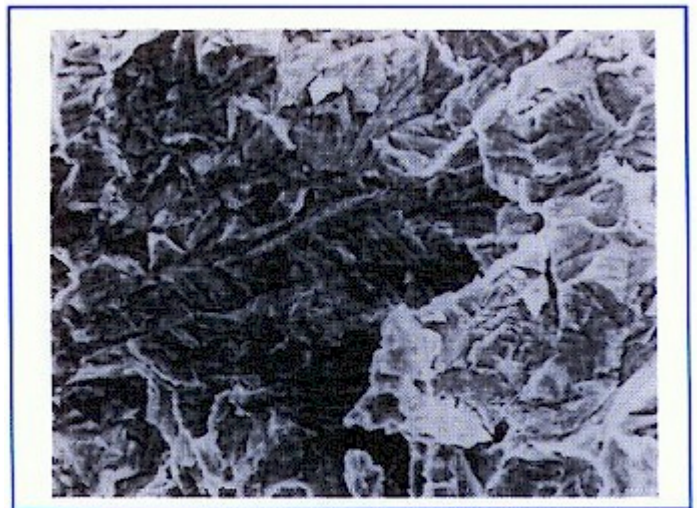
Figure 2 1,000 Magnifications

The transgranular, feathery topography shown is a textbook example of CSCC.

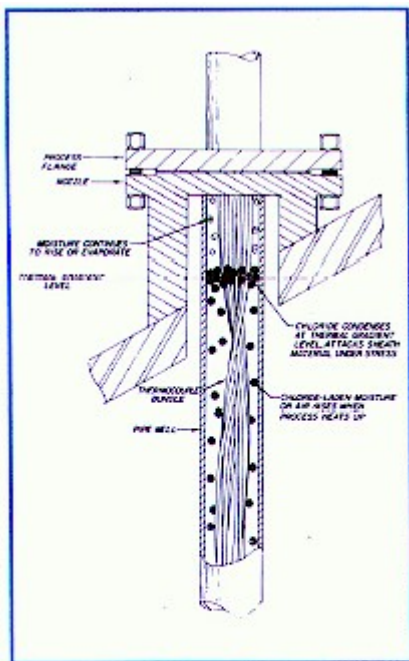
Figure 3

For CSCC to occur, high chloride concentration and stress levels must be present. These conditions occur in pipewells because of the thermal gradient that exists at the vessel penetrations, where the pipewell goes quickly from process temperature to ambient temperature. Such radical and rapid temperature changes cause mechanical stress on the pipewell, creating a condensate region within.

This becomes a problem only when chlorine-laden air is allowed to enter the pipewell, vaporize in the presence of process temperatures, and then condense in the cooler area of the pipewell that is exposed to ambient temperature. As this cycle continues to repeat itself, chloride ions concentrate. The chlorine-laden air fueling the concentration cell can come from various sources; however, the two most common are cooling towers and steam lances. A third, though less common source, is water that has been allowed to enter the pipewell during turnaround.

As water evaporates at the thermal gradient zone, chlorine ions concentrate and attack the sheath.
